SERVICE BULLETIN K4900 SERIES VERTICAL DEFLECTION CIRCUIT REVISION

All K4900 Series Monitors including, but not limited to, the following model numbers:

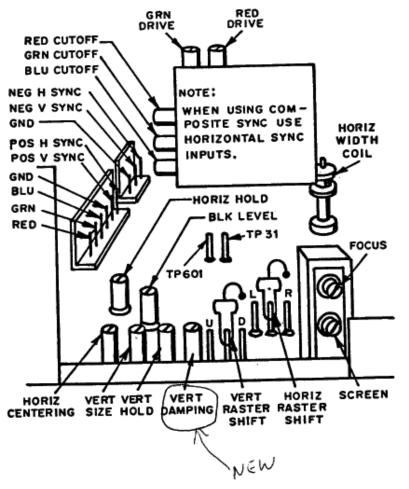
- A) The model number on the shipping carton and on the monitor is printed in red;
- B) The part number on the deflection yoke is either 2021111258 or 2021111264.
- C) The flyback transformer stabilizing bracket is labeled 611X0005-008.
- D) There is an additional control, the VERTICAL DAMPING CONTROL shown above immediately to the right of the Vertical Hold Control.

The applicable monitors have an improved deflection yoke which provides for faster vertical retrace. This permits more lines of video to be displayed. The VERTICAL DAMPING CONTROL permits the user to adjust the uniformity of spacing of the additional lines.

The adjustment of the VERTICAL DAMPING CONTROL is important only if the vertical size is adjusted such that the additional lines appear on the screen. Turn up the Black Level Control such that the raster lines can be seen. Adjust the Vertical Damping Control such that the top raster lines are spaced uniformly and not folded over. Return the Black Level Control to the desired setting.
